F-3 RENOVATION

2007 | CV#: F3  
Craftsman Bungalow – 960 SF Phoenix, Arizona

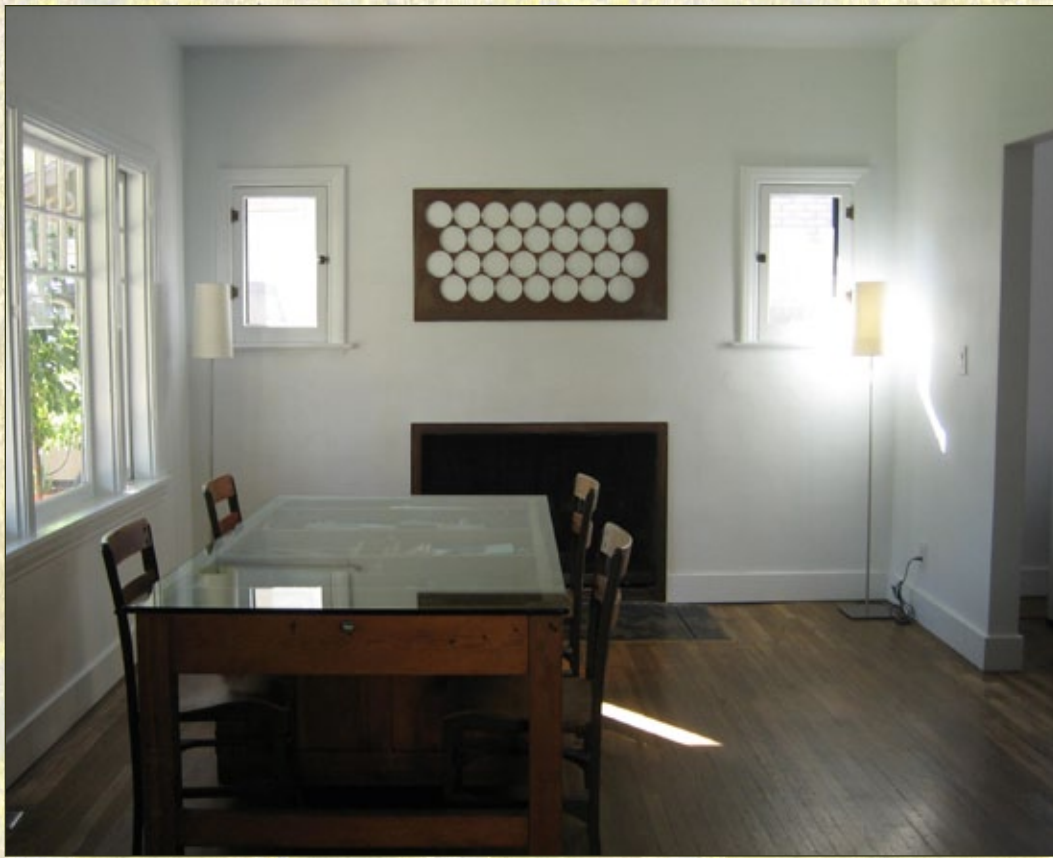
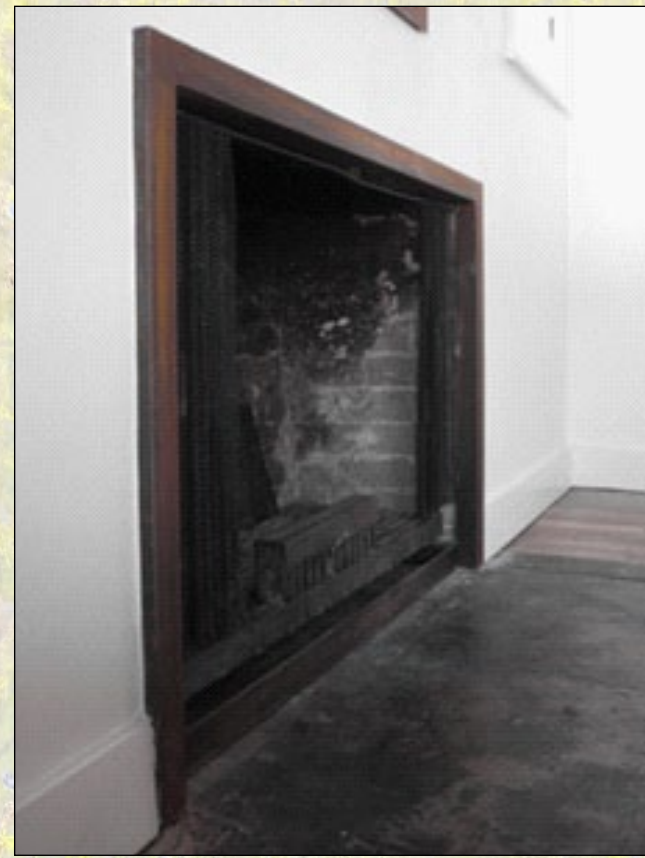
## LIVING ROOM

The original wood floors were sanded, stained, and re-finished. The hearth is also original; however, the mantel and built-in shelving and that once flanked both sides of the fireplace when it was built in 1925 had been removed by a realtor who was attempting to flip the house prior to the acquisition of this home by its current owners. Rather than replicate the missing artifact, a simple surround was fabricated from steel and allowed to patina naturally. Raised grating was also added inside to aid in better functioning of the fireplace.

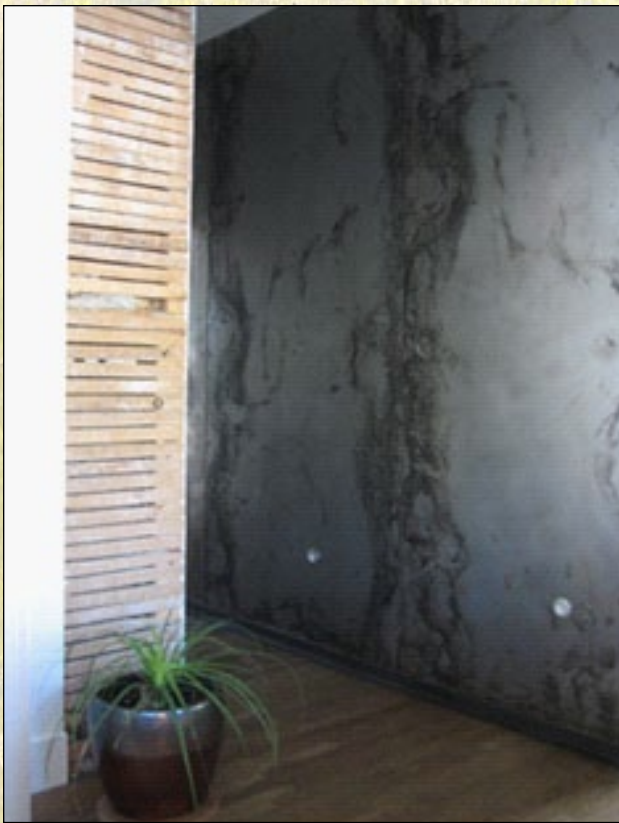
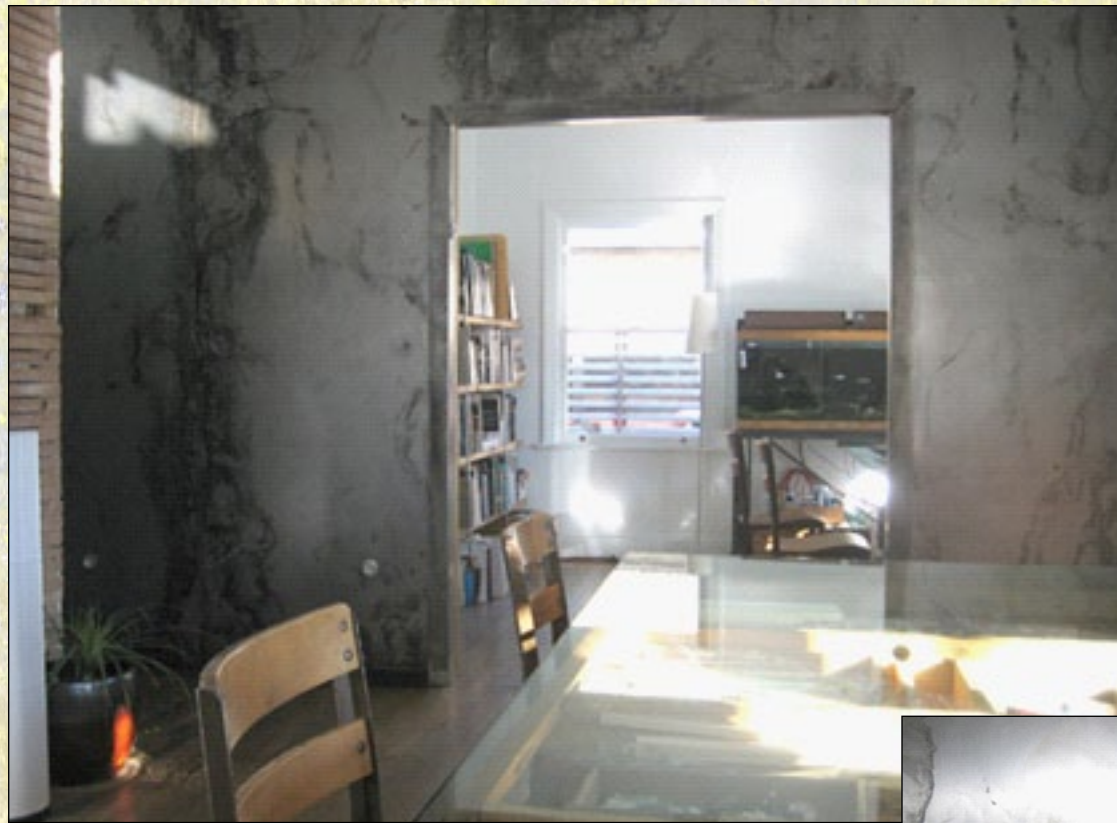
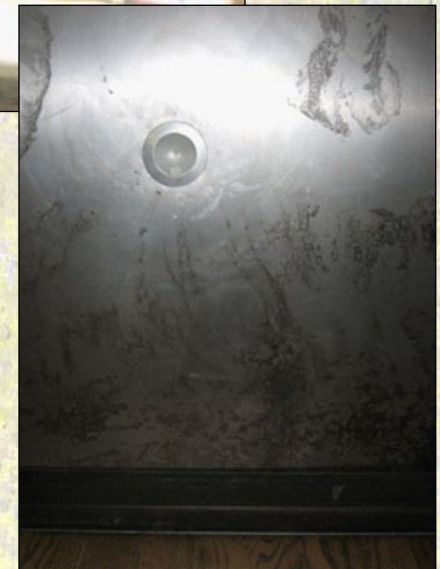
**HALLWAY**

The most dominant feature created in the house is an accent wall made of black oxidized steel plate running along one side of the main hallway. What makes this application particularly interesting is that it has no exposed fasteners. A steel angle base enables the wall to transition seamlessly against the wood floor. This striking wall is one of the first elements what strikes the visitor upon entering the home, and it sets the tone for an almost industrial aesthetic and use of raw finishes that is carried throughout the remainder of the home.

Note the section of existing wood lath, left intentionally to display this type of early wall construction type found throughout the house. Although the original plaster walls have mostly been refinished with smooth drywall, much of the original lath still remains intact underneath.

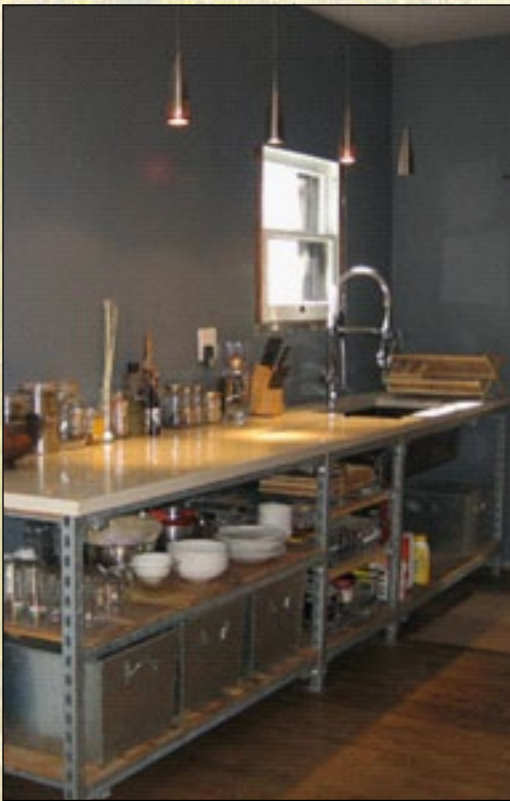
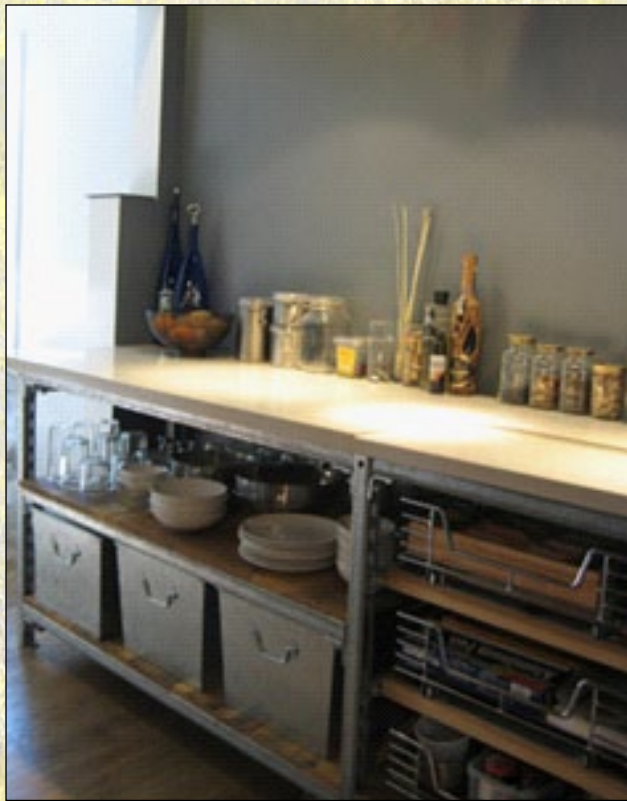
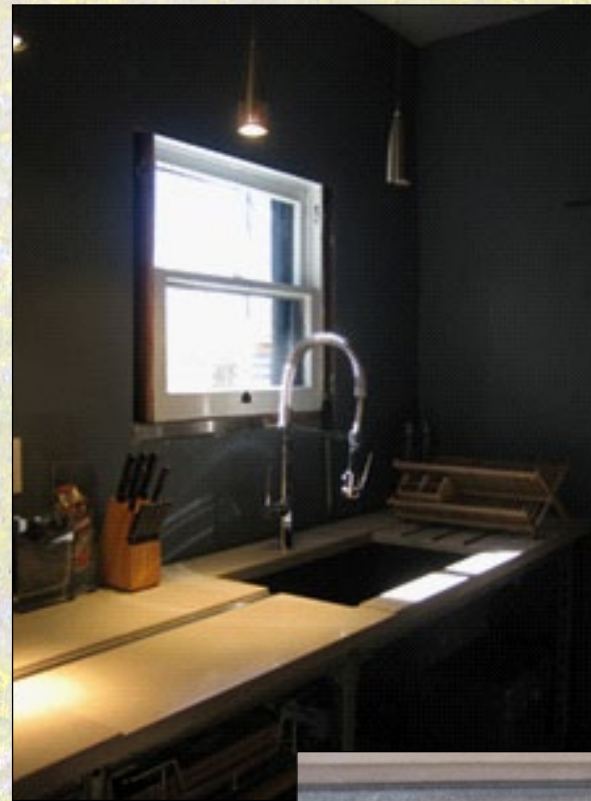
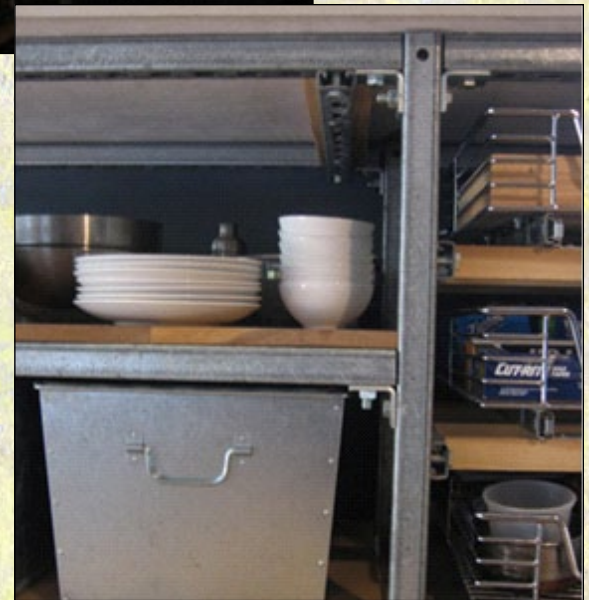
## KITCHEN

The kitchen was one area of the house that needed to be re-structured entirely. It was evident from the start that this room had been through numerous renovations from previous owners. A dropped ceiling with a fluorescent light cove was removed, along with upper and lower particle-board cabinetry, and all appliances are soon to be replaced.

The industrial theme is really showcased in the kitchen, from the unistrut framing of the shelving to the concrete countertop, to the chalkboard wall. Custom accessories fabricated by Carbon-Vudu include the hanging pot rack and the spice shelf. (The countertop was expertly built to custom specifications by Everything Concrete Design Studio, <http://www.theconcreteculture.com>)

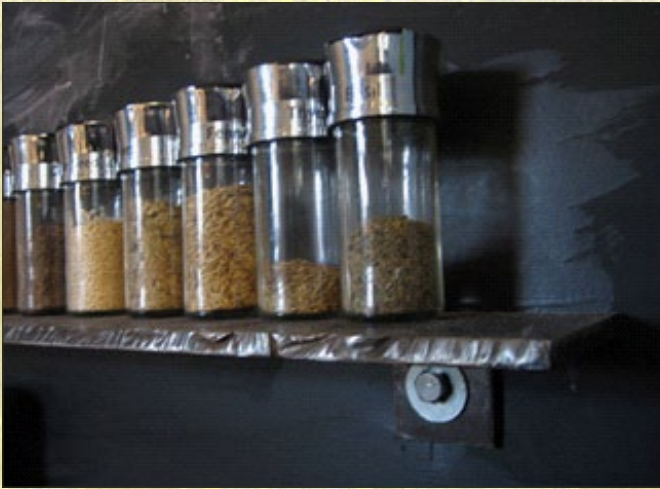
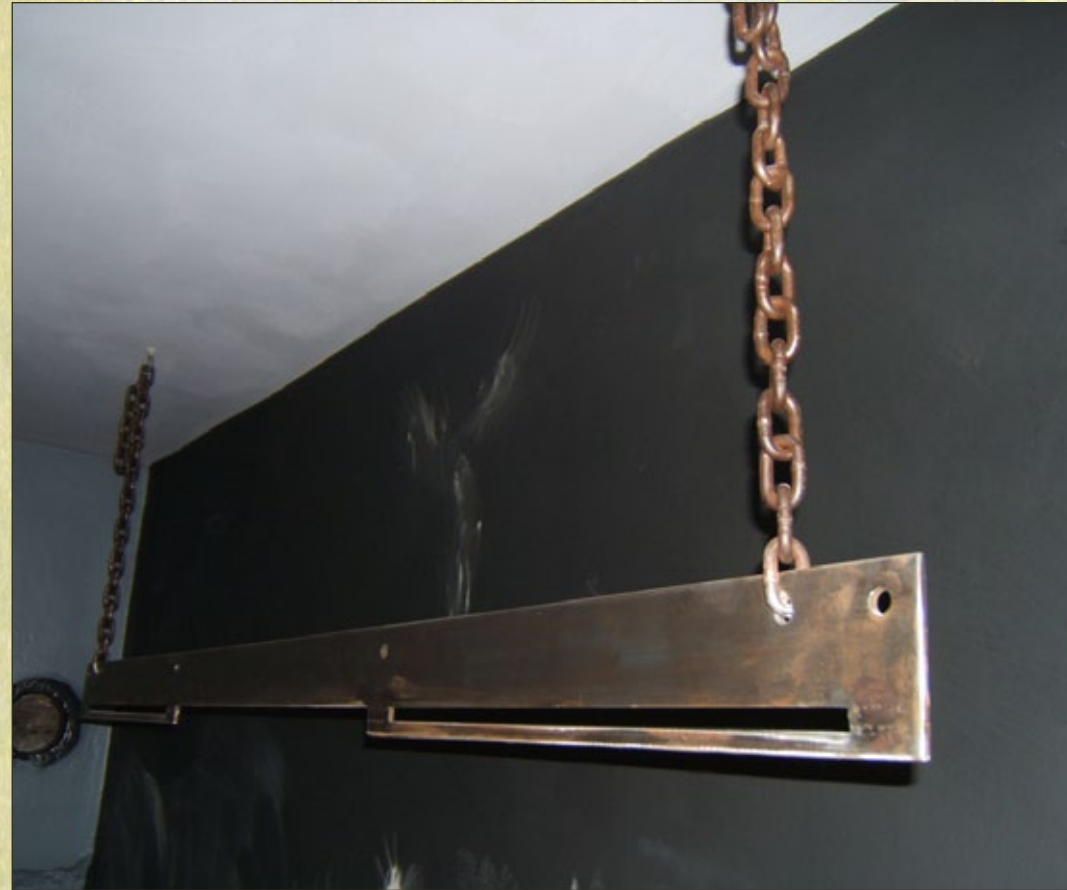
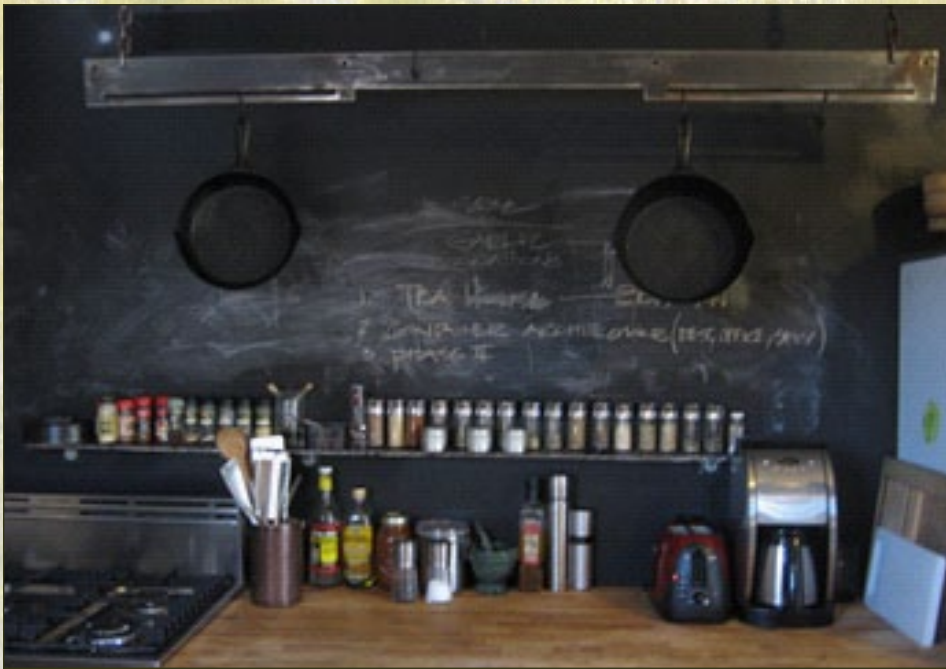
# KITCHEN

This is a true working kitchen where meals are actually cooked and prepared on a daily basis. Therefore, all components and furnishings within are designed for ready access and ease of cleaning.

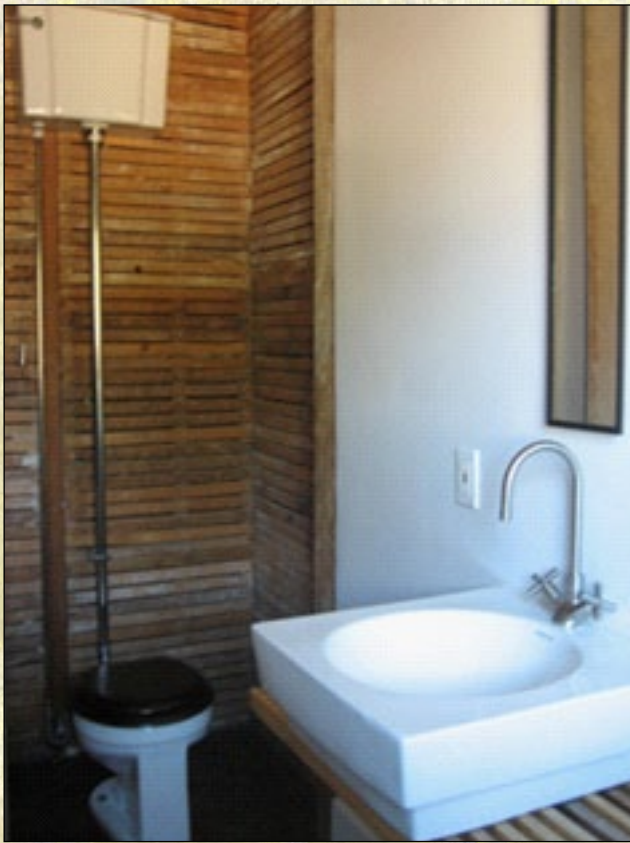
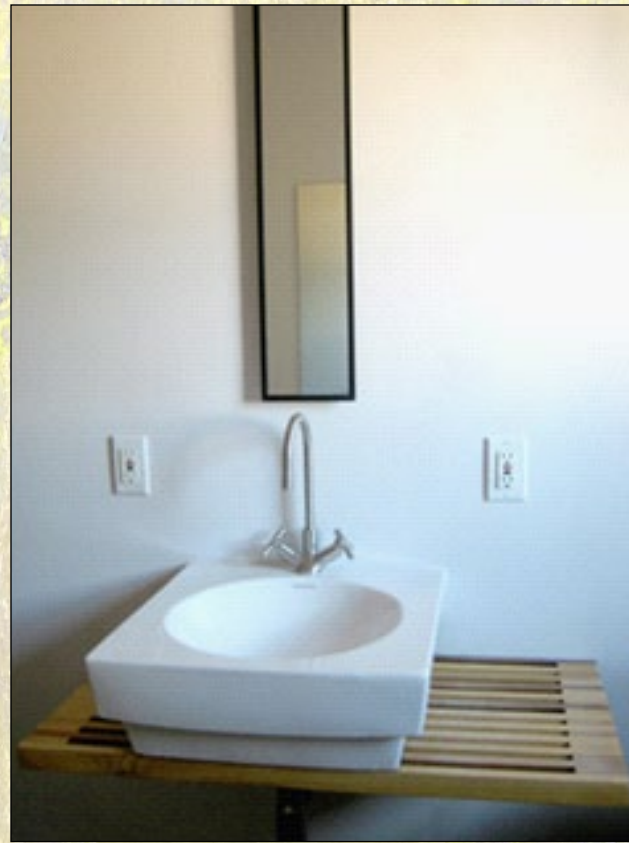
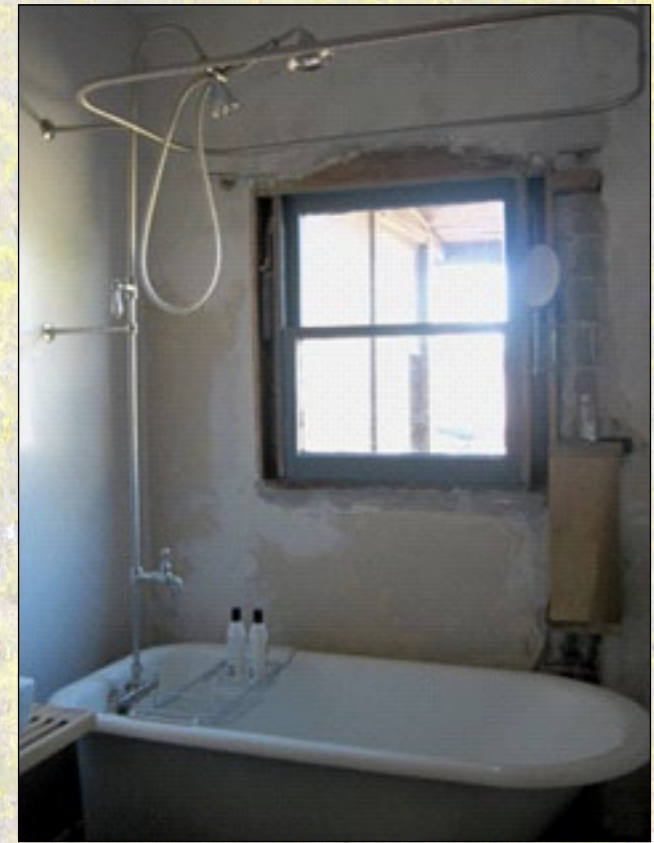
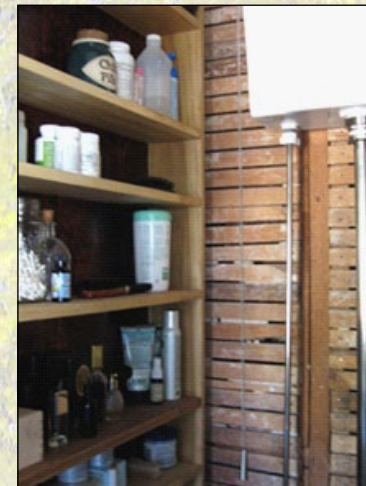
## BATHROOM

One enters the bathroom through a floor-to-ceiling sliding door (not shown) which either hides the water closet when fully opened, or closes off the room for privacy when shut. Features of this room include the exterior window wall, left rough and partially finished so that even the anatomy of the double-hung window is exposed. This contrasts powerfully against the tall, smooth white walls and clean porcelain and satin nickel finish of the bath fixtures. The 1925 cast iron tub, which harkens from the same year in which the house was built, was procured from a local ceramic refinisher and was not actually original to the home. Carbon-Vudu also fabricated the poplar shelf that holds the lavatory sink, the matching poplar shelving next to the water closet, and the wood box shelf to the right of the window.

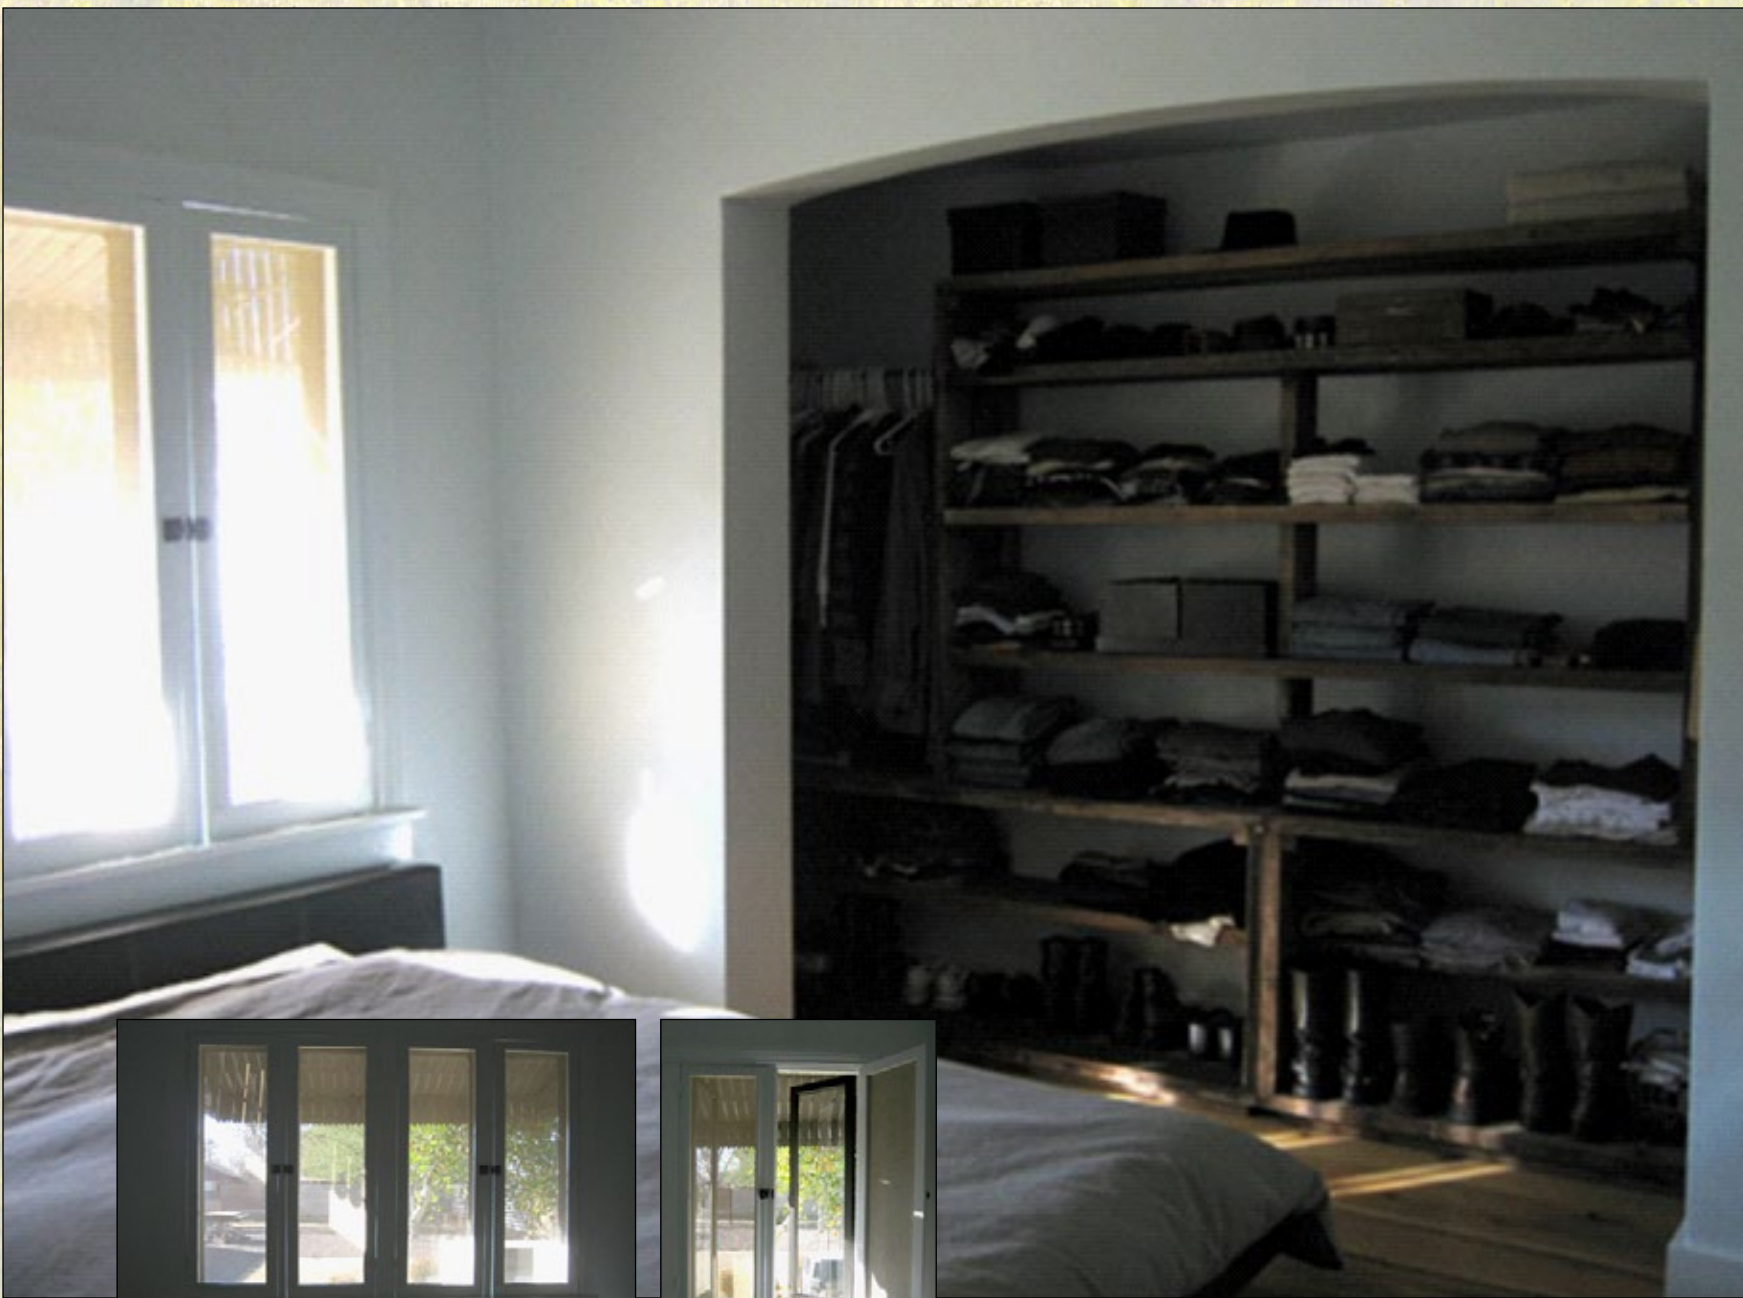
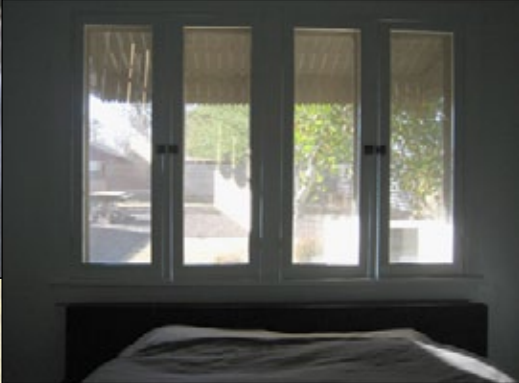
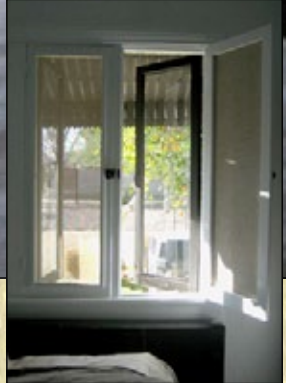
## MASTER BEDROOM

It is rumored that the master bedroom was once a sleeping porch, and evidenced by the change in wood floor framing and material, a hidden doorway, and the masonry arched opening that currently frames the closet opening as if it once was a doorway to the outside. The current closet space was an addition, constructed some decades ago on an unknown date. Its arched top was previously concealed by a wood frame and jamb, and was only recently liberated to show off its original curved splendor. The closet shelving is constructed from reclaimed redwood procured and reused from a separate Carbon-Vudu project. The worn out window screens shown in the above photographs were replaced, and the original hardware was stripped of years of paint to expose a beautiful oiled bronze finish.

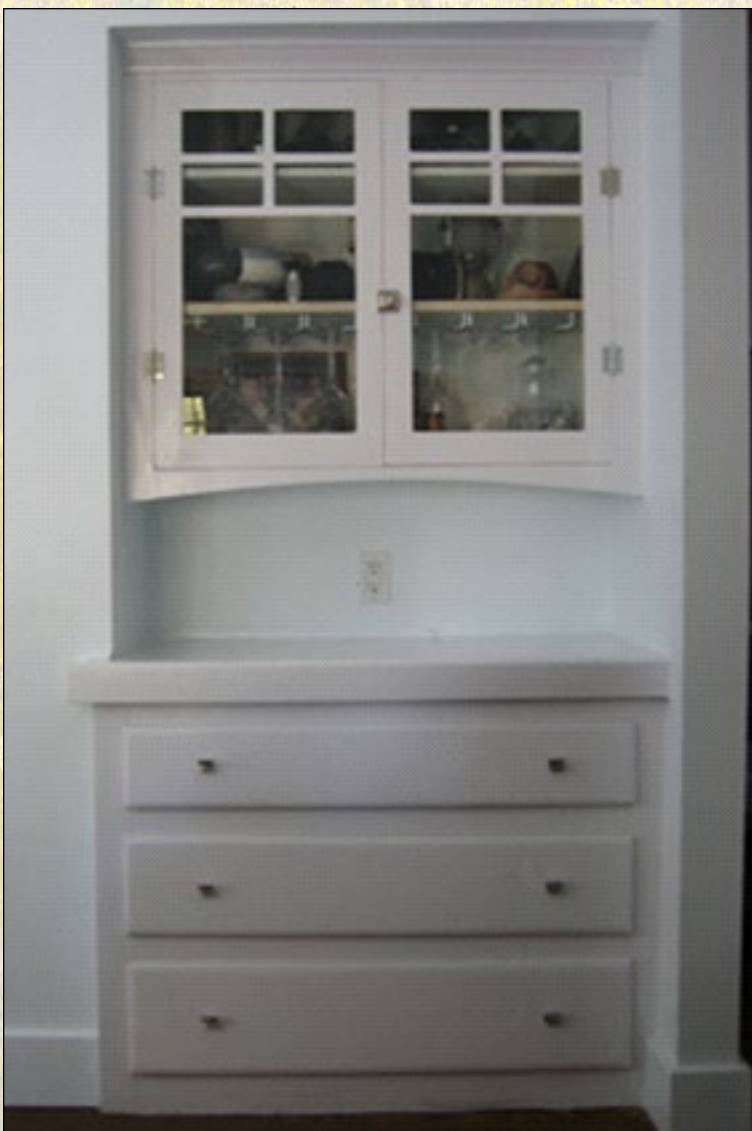
Refinished Built-in Credenza with new Hardware

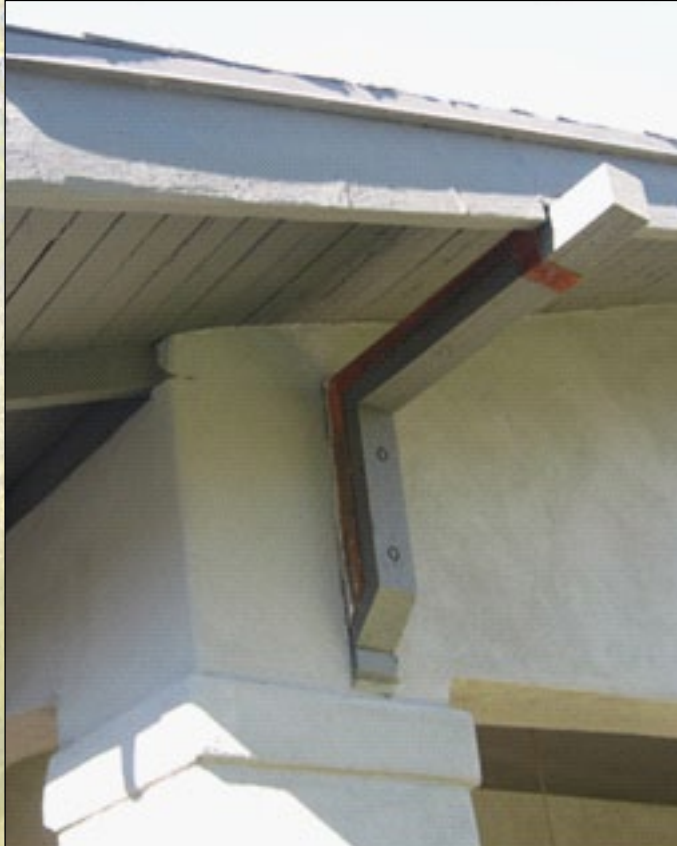
Overhang Bracket: Pressure-treated Wood and Steel

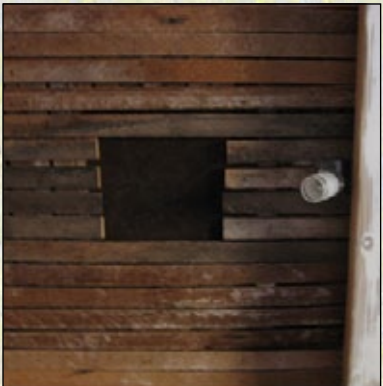
Perforated Metal Exhaust Fan Cover (at Water Closet)

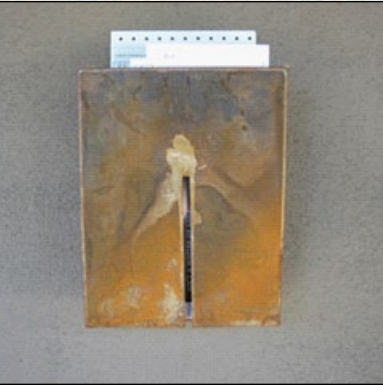
Steel Mailbox
